DuPont™ Engineering Polymers

Failure Analysis using Microscopic Techniques

Failure Analysis
on Moulded Parts of
DELRIN® and ZYTEL®
using Microscopic Techniques

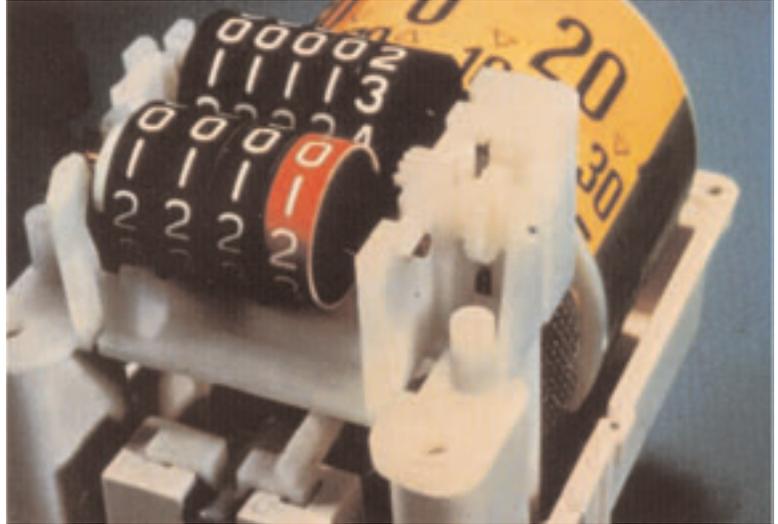
A Parts

Reason for Failure:
Inhomogeneous melt increased brittleness and lowered resistance to impact load on start-up of gear.

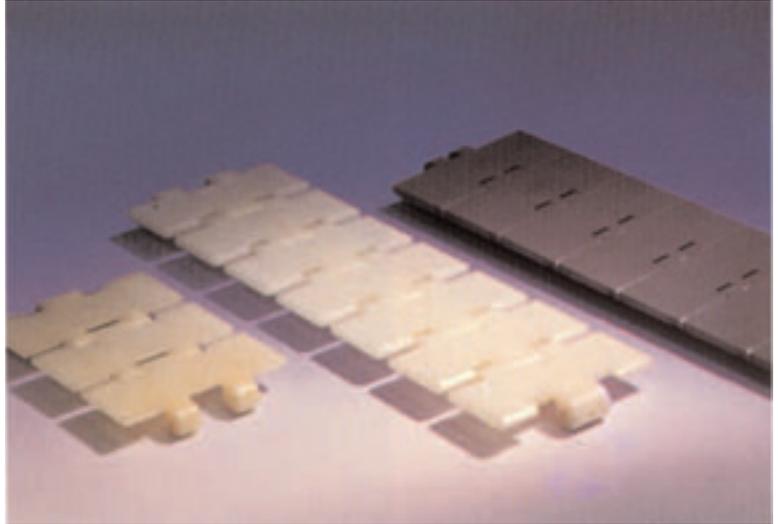
A Parts

Reason for Failure:
Insufficient filling of cavity (voids) and inhomogeneous melt was reason for premature failure.

Remark:
The thick section should be redesigned to remove the tendency to form voids.

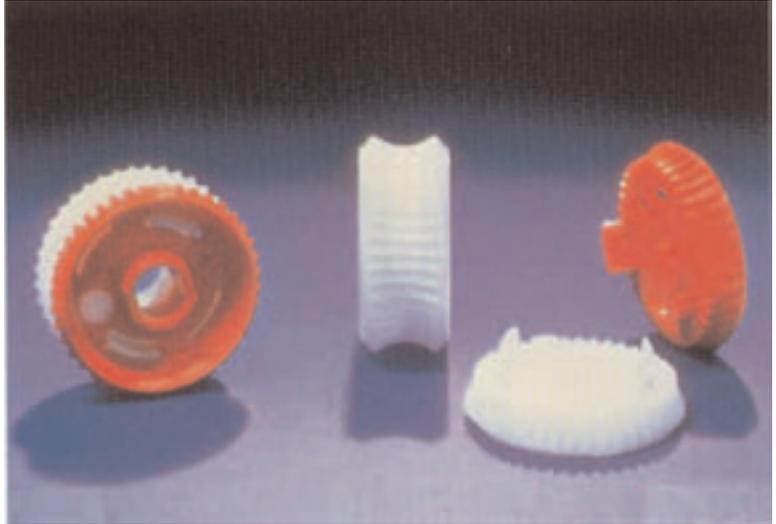
A Part

Reason for Failure:
Unmolten particles due to too low melt temperature reducing strength of gear teeth.

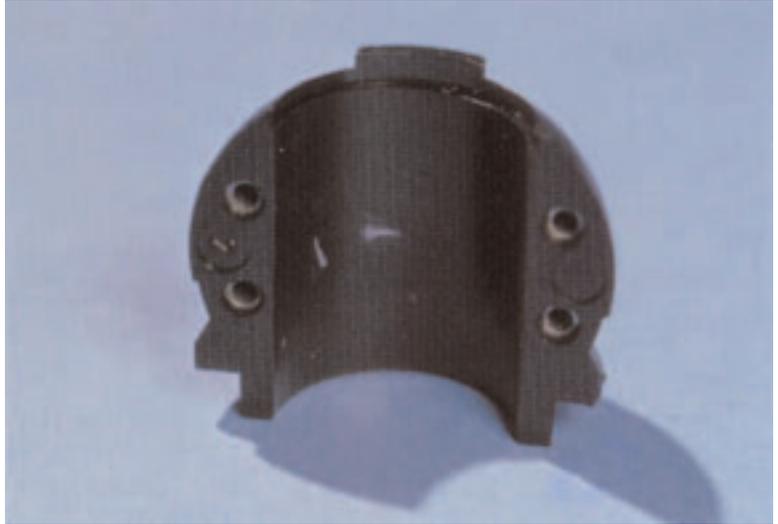
A Part

Reason for Failure:
Microtome cross section prepared from area of white spots revealed unmolten particles. These would cause premature failure.

Remark:
Additional determination of melting point from inspected area confirmed that white spots were the same POM as the homogeneous black resin.

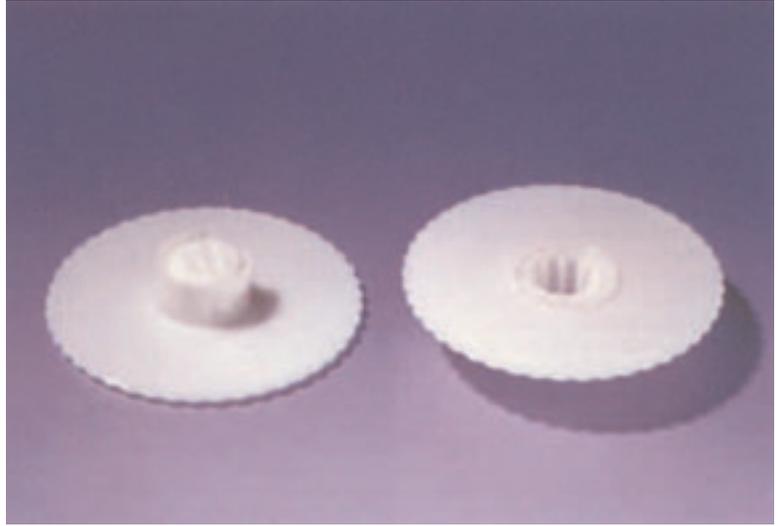
A Part

Reason for Failure:
Both problems due to inhomogeneous melt.

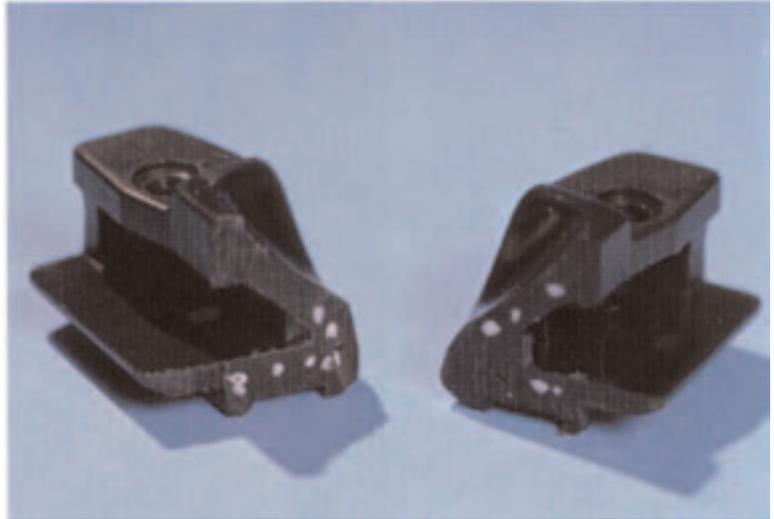
A Part, break area

Reason for Failure:
White spots are particles of the natural resin which due to too low a melt temperature were not completely molten and thus acted like a contaminant reducing impact strength.

Remark:
In addition, parts are insufficiently filled resulting in voids.

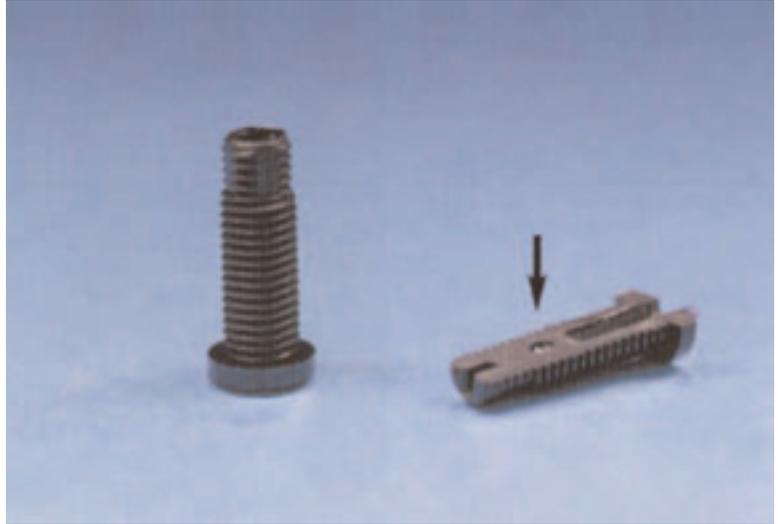
A Part

Reason for Failure:
Inhomogeneous melt and
sharp angle at first thread caused
brittleness.

Remark:
If the microtome cut or polished
section becomes **too thin**,
recognition of failure in structure
is not possible (see photo D).

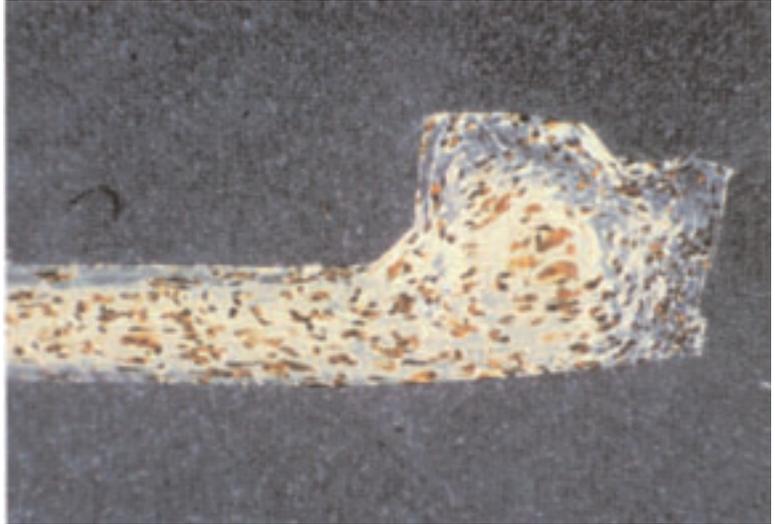
Problem:
Overmoulding cracked under load.

Reason for Failure:
Inhomogeneous melt caused
brittleness.

A Inhomogeneous melt

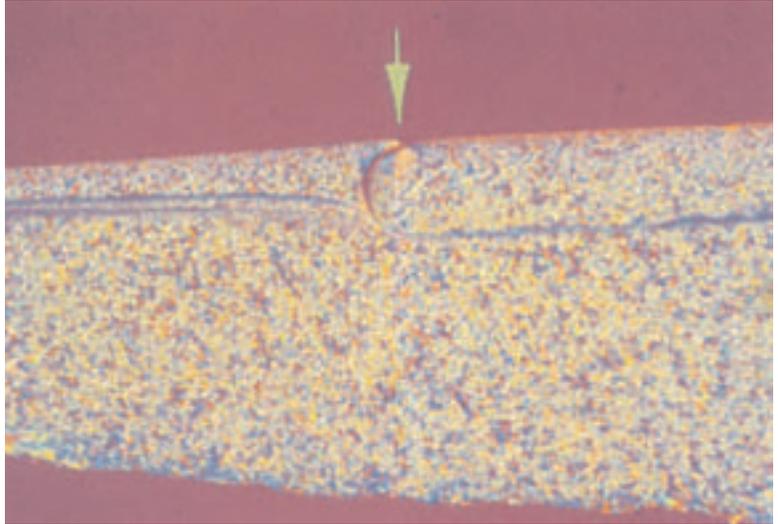
Problem:
Quality control rejected parts showing surface defects easily detectable by naked eye.

Reason for Failure:
Cold thread from nozzle of moulding machine caused notch effect on surface (see arrow) emphasized by cold material underneath.

A Thread of cold material near surface

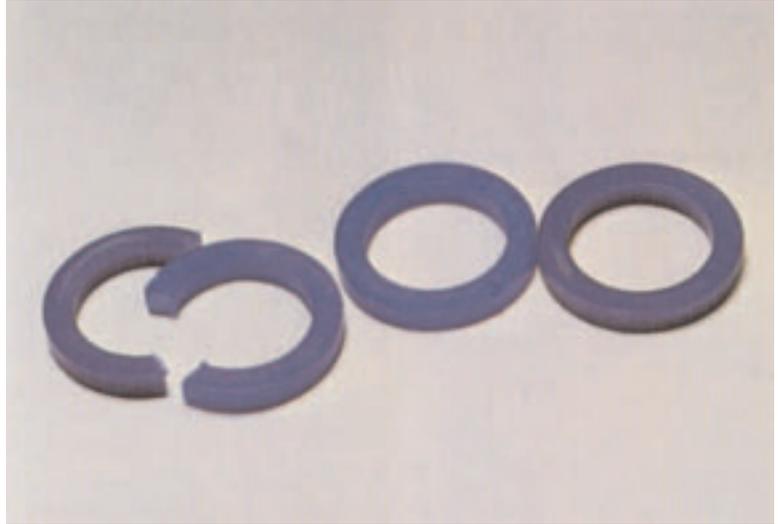
A Parts

Reason for Failure:
Inhomogeneous melt prevented uniform absorption of dye.

Remark:
Speed of water absorption is influenced by size of spherulites. (Smaller spherulites = slower water absorption.) Thus non-uniform size of spherulites caused non-uniform absorption of water containing dissolved dye.

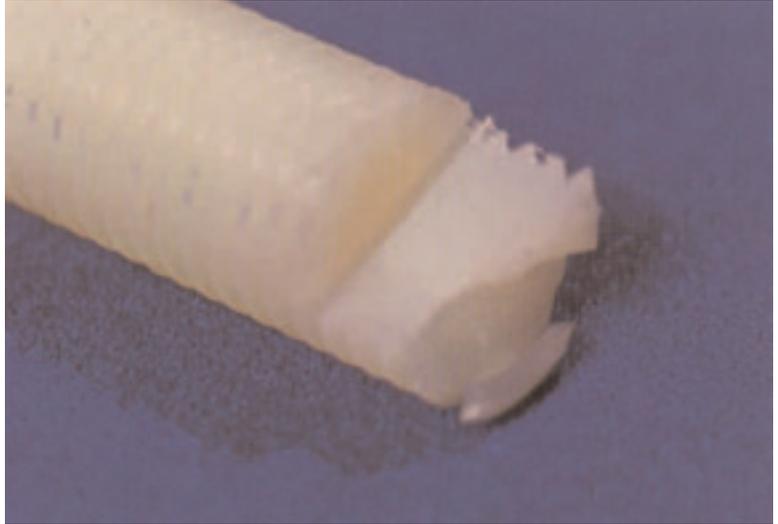
Reason for Failure:
Unmolten particles in extruded material caused brittleness.

Remark:
The material giving no problem in machining showed a homogeneous structure.

A Rod with brittle break

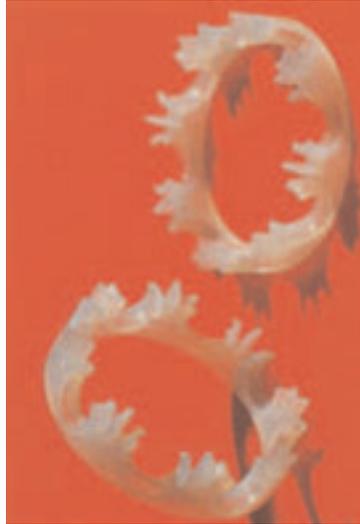
A Parts

Reason for Failure:
Series of decreasing quality show decrease in homogeneity of structure, e. g. melt temperature was getting lower from one series to the next.

Remark:
Series with strong distortion show in addition weld line due to too low a melt temperature.

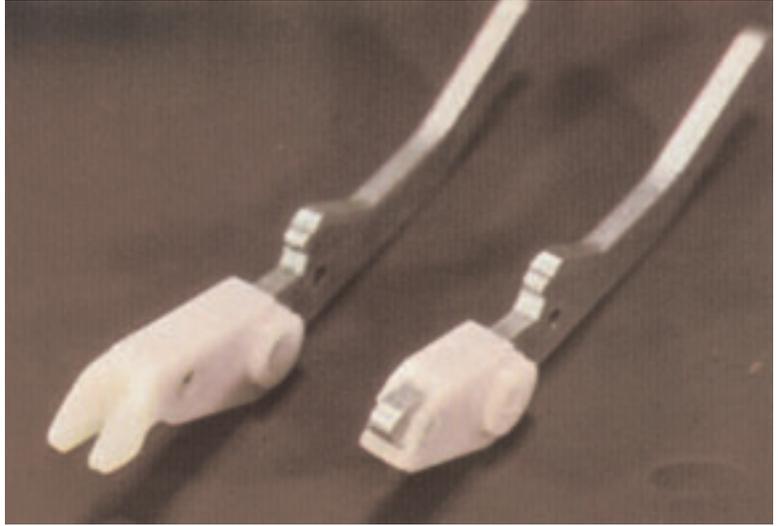
A Part

Reason for Failure:
Inhomogeneous melt reduced impact strength and elongation.

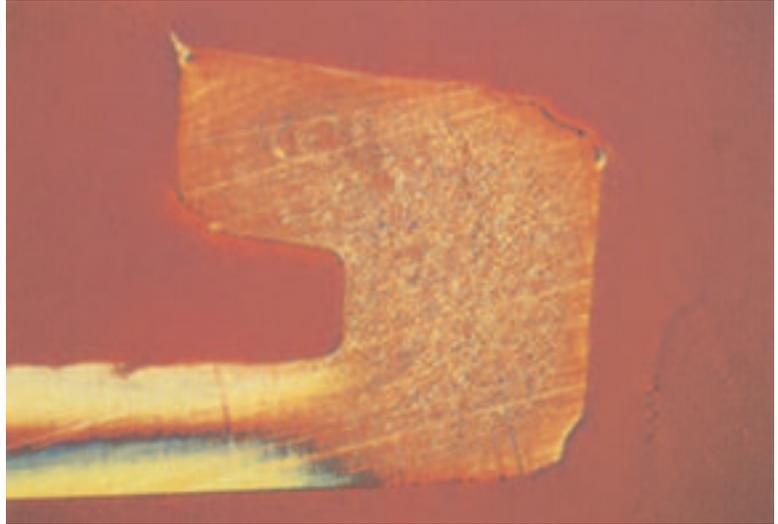
Reason for Failure:
In comparison to the rings which
performed satisfactorily the soft
rings had a lower crystallinity
(more transparent appearance).
Thus stiff-ness was reduced.

A High crystallinity

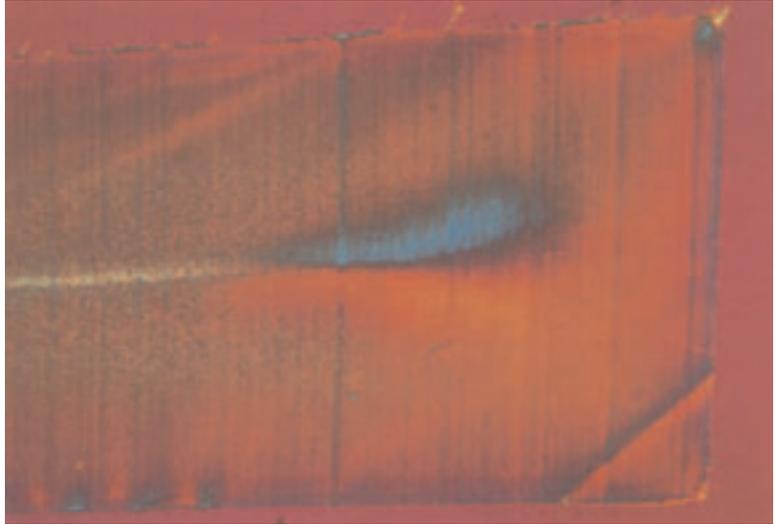
Reason for Failure:
Poor melt quality and low melt
temperature caused irregular impact
resistance.

Remark:
As proof, impact bars were moulded
with correct and too low melt
temperature. Failure could be
reproduced. Moulding parameters
other than cold melt are difficult
to recognize in the structure of
modified PA.

A Correct melt

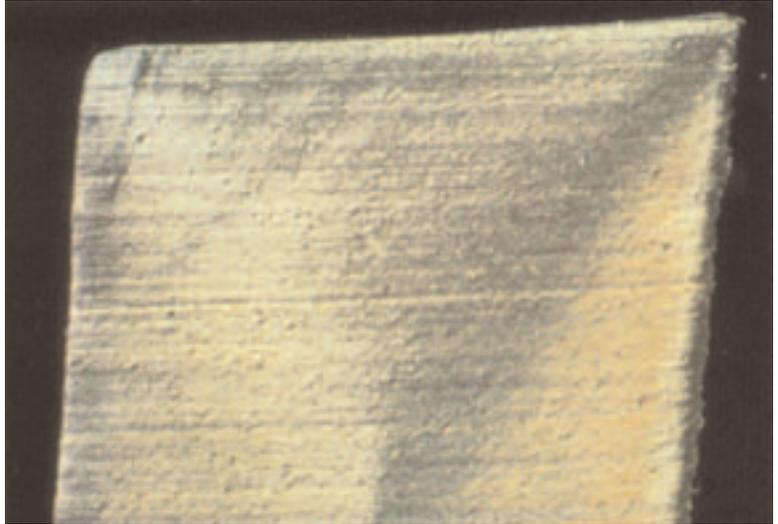
Reason for Failure:
Standard tensile bars (3,2 mm thickness) moulded with correct and 20°C lower melt temperature reveal evidence of cold melt in thin section.

A Correct melt temperature

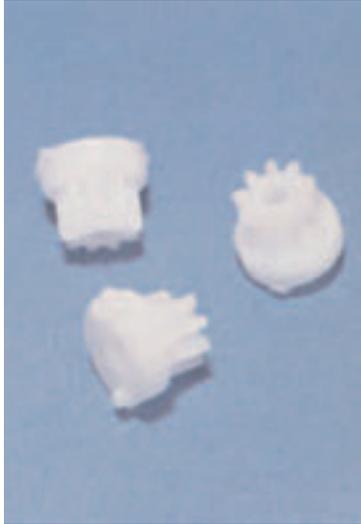
A Part

Weld line due to too cold melt temperature when melt flows meet. In some gears the weld line is located at a tooth base angle (D).

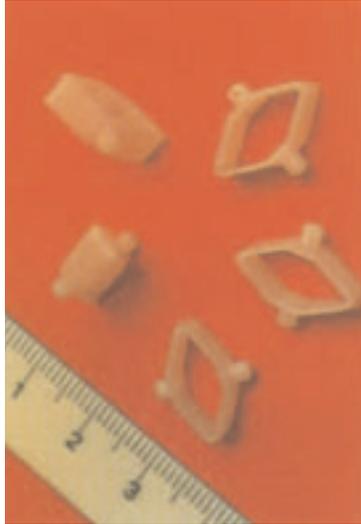
A Trim clip

Remark:
Weld line does not appear throughout the whole cross section. Therefore notch effect from surface only when stressed during assembling (see area between arrows on photo D).

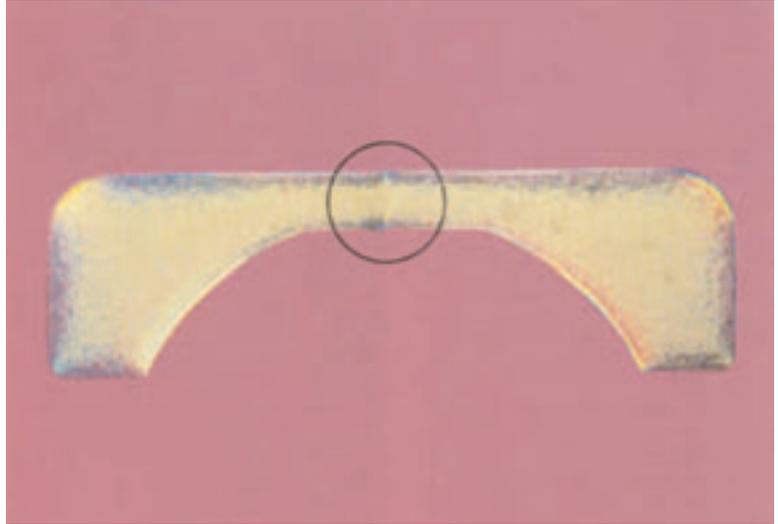
Reason for Failure:
In comparison to parts within limits of test specification, the failing parts show a distinct weld line in cross section.

A Weld line

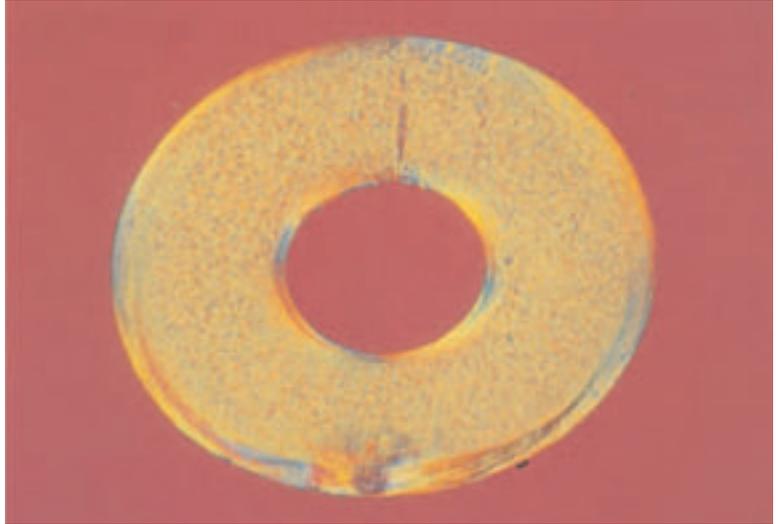
Problem:
Bushings crack opposite to gate when forced onto axle.

Reason for Failure:
Melt has been cooled off too much while flowing in cavity around the core preventing a homogeneous weld. Reason can be too low melt temperature or too slow injection speed.

A Weld line

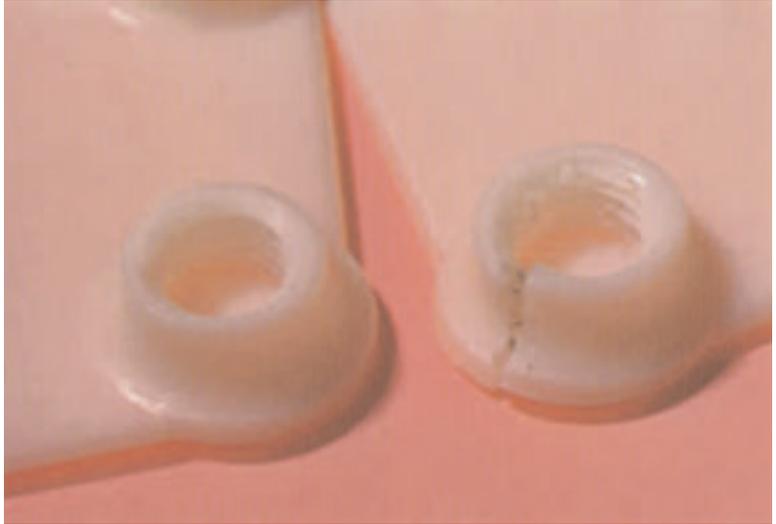
A Part showing crack

Weld line in structure goes through the whole cross section. Weld line appears when melt is already too cold and material flow meets behind the core.

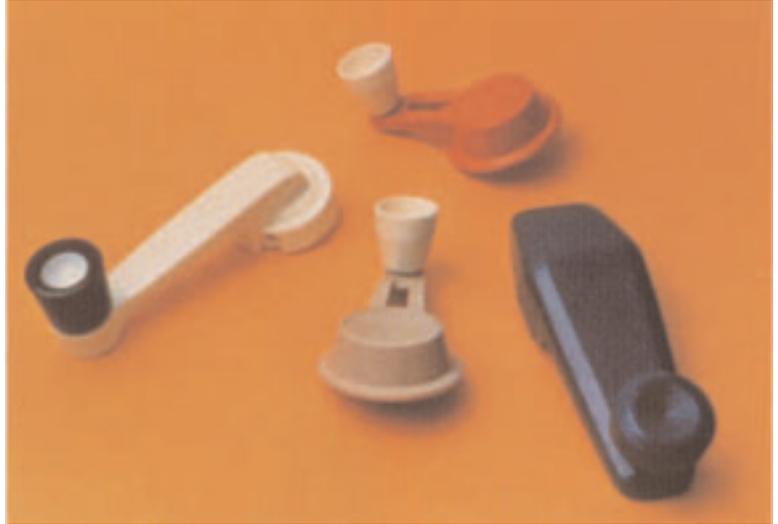
A Parts

Remark:
The low melt temperature also prevented homogeneous dispersion of masterbatch.

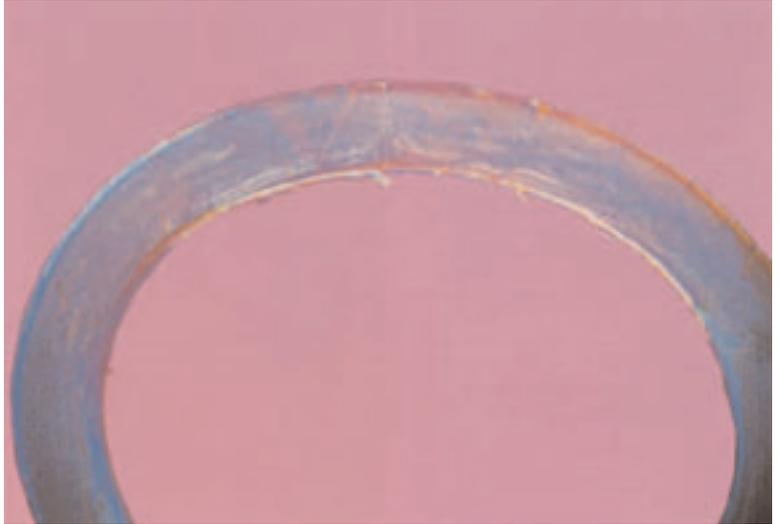
Reason for Failure:
Weld line clearly visible in thin section due to too low melt temperature.

A Low melt temperature = weld line

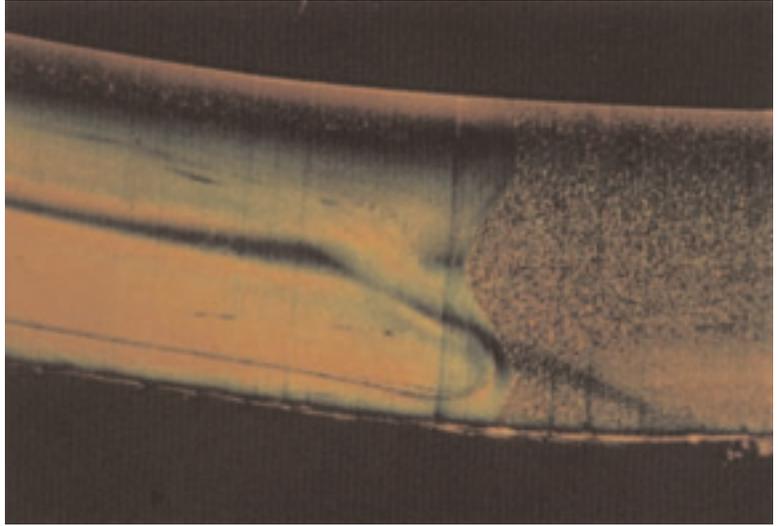
Reason for Failure:
Two reasons, both due to too low
melt temperature.
a) weld line (in S-shape)
b) partially finer structure similar to
nucleated PA. The latter has lower
elongation in dry-as moulded
condition than normal structure

A Weld line

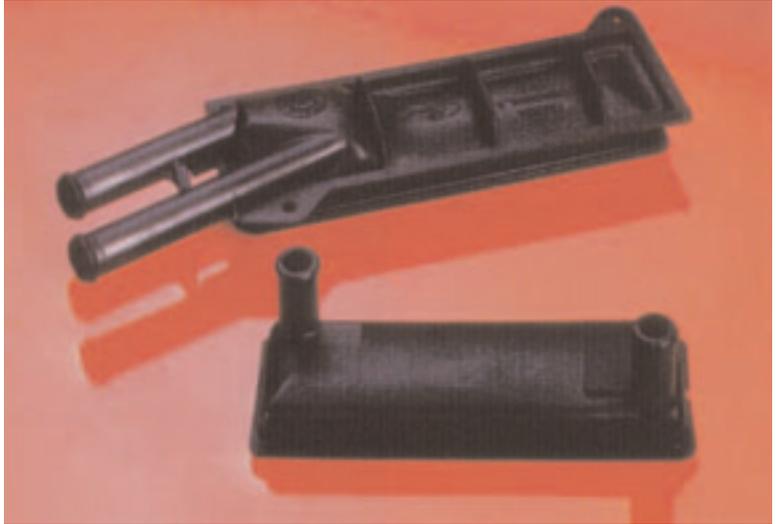
A Part

Remark:
S-shape of weld line in glass reinforced PA seems to give good mechanical strength. Best observation is without any filter.

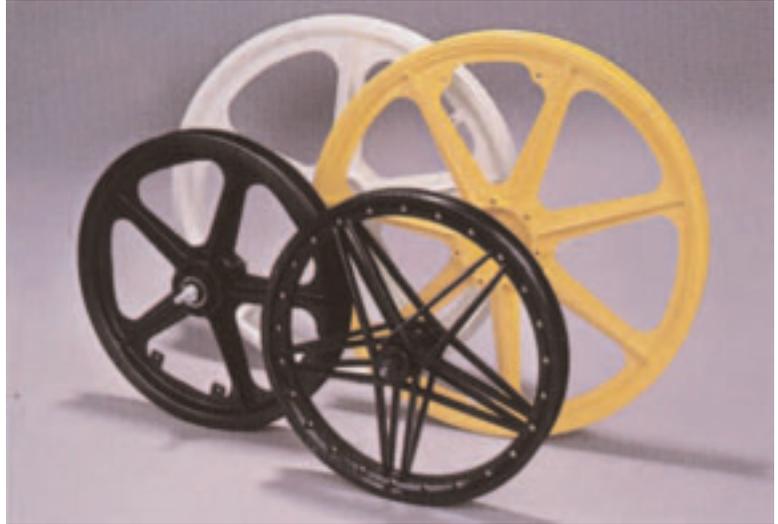
A Wheels

Reason for Failure:
Presence of weld line can not be eliminate. In this case impact tests confirmed sufficient mechanical strength.

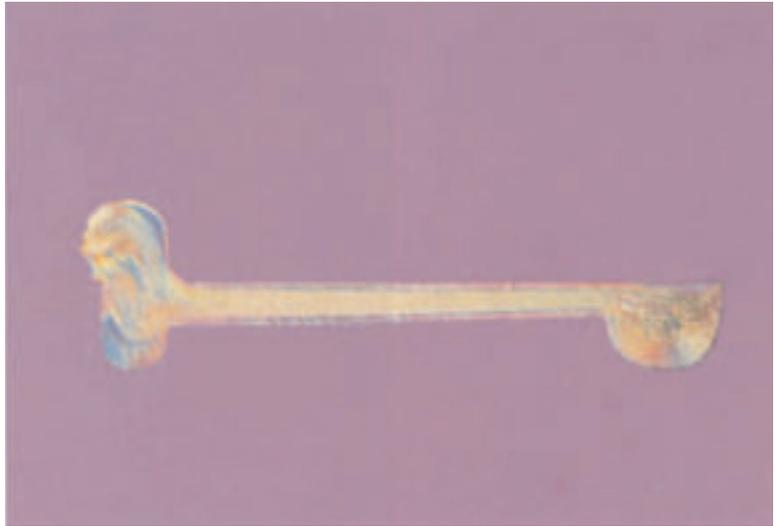
A Part

Remark:
Systematic studies on effect of mould temperature on mechanical properties of POM-homopolymer have explained different behaviour (see literature).

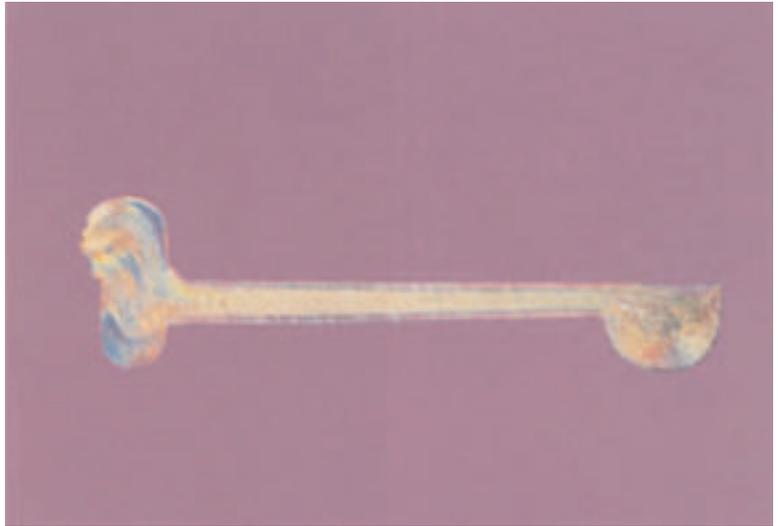
A Part

Reason for Failure:
Structure shows line of too short SFT, reducing mechanical properties.

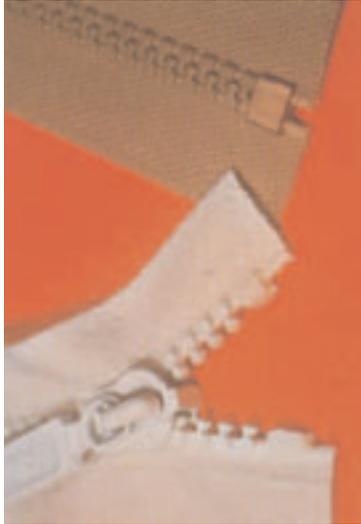
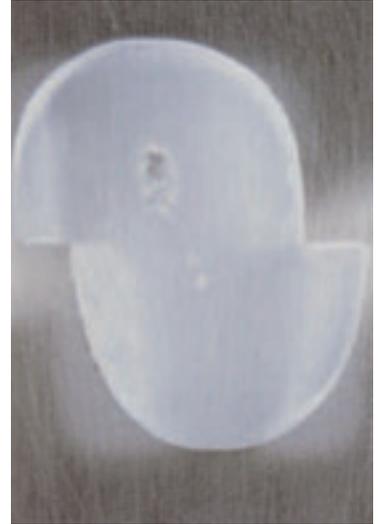
A Zipper

Reason for Failure:
Insufficient filling of mould cavity resulting in voids. Thus, reduced cross section gives lower mechanical strength.

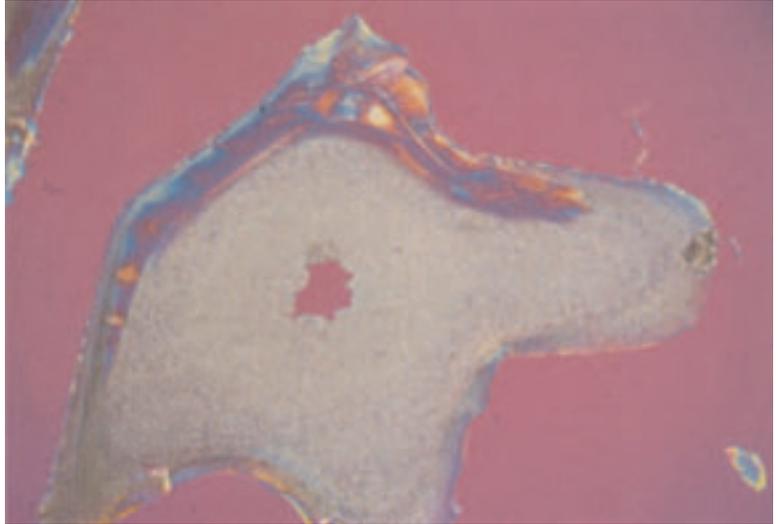
Remark:
Failing parts were also not well filled showing big voids in center. Thus the functional cross section was reduced too.

A Strong shear at gate

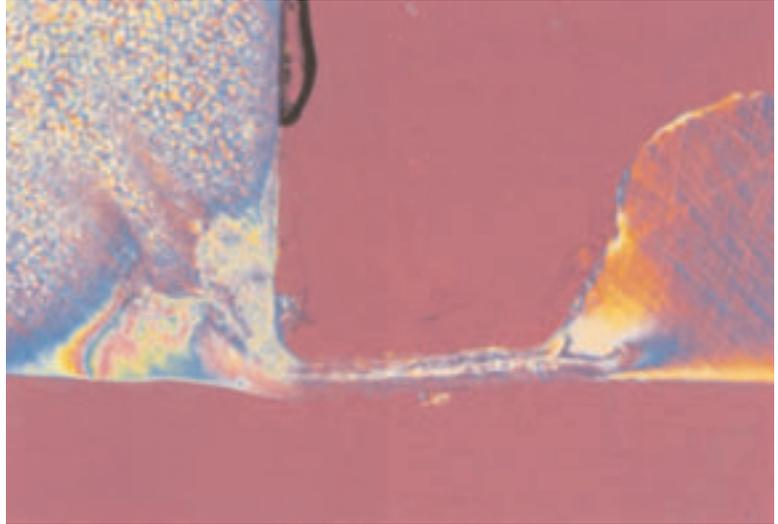
Reason for Failure:
Shear orientation is clearly seen at corners of thin wall cross section. The reduced strength perpendicular to the orientation results in breakage in the desired area.

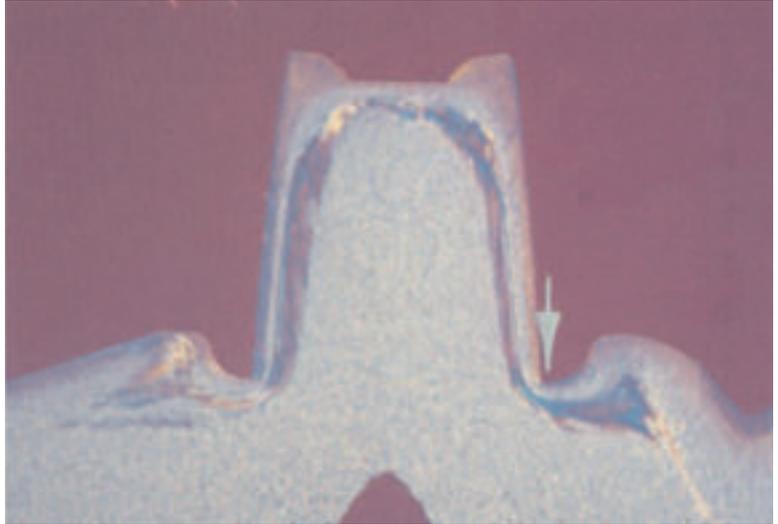
Remark:
Sharp corners increase brittleness even with parts of conditioned nylon.

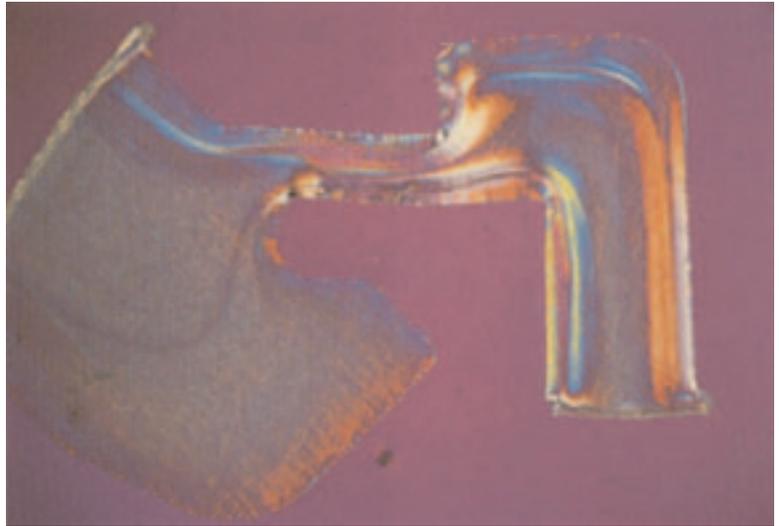
Remark:
Additional notch effect in corner of flexioned area caused by damaged surface of mould (see arrow in photo B).

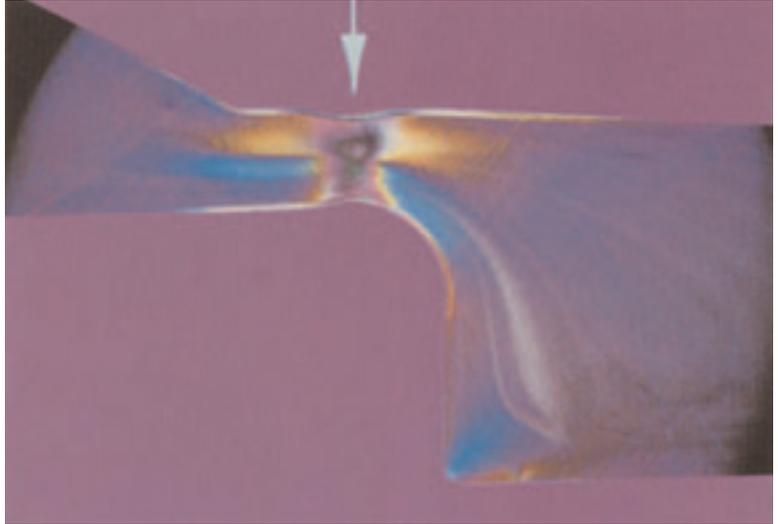
Remark:
Even without presence of shear orientation cold or inhomogeneous melt causes brittleness of parts.

A Hinge

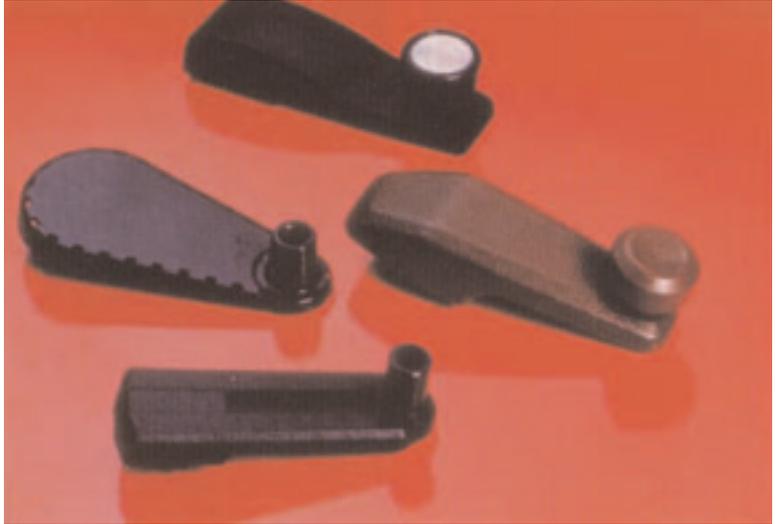
A Part

Reason for Failure:
Inhomogeneous melt or too low melt temperature prevented uniform distribution of the colour masterbatch.

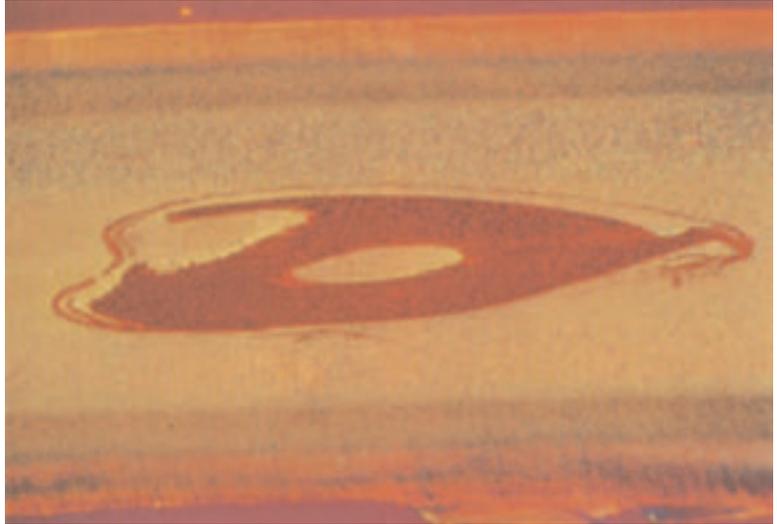
Remark:
Insufficiently dispersed masterbatch may indicate inhomogeneous melt.

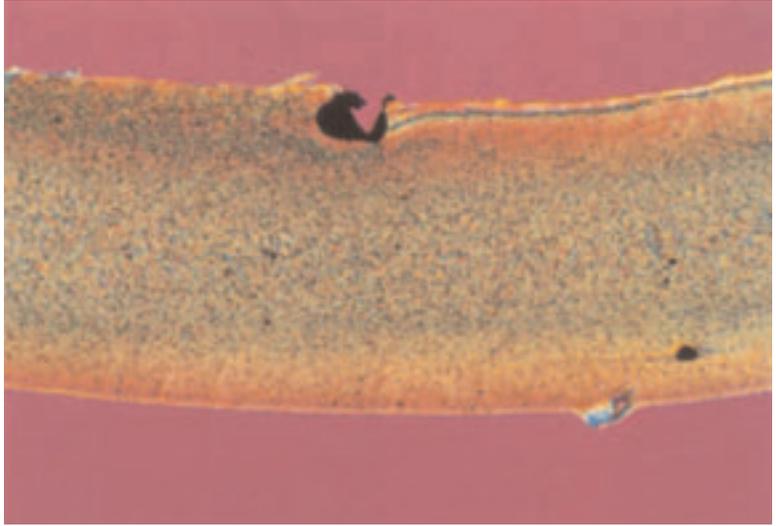
Reason for Failure:
Colouring with dry pigment caused pigment agglomeration which acts like foreign particles causing premature breakage.

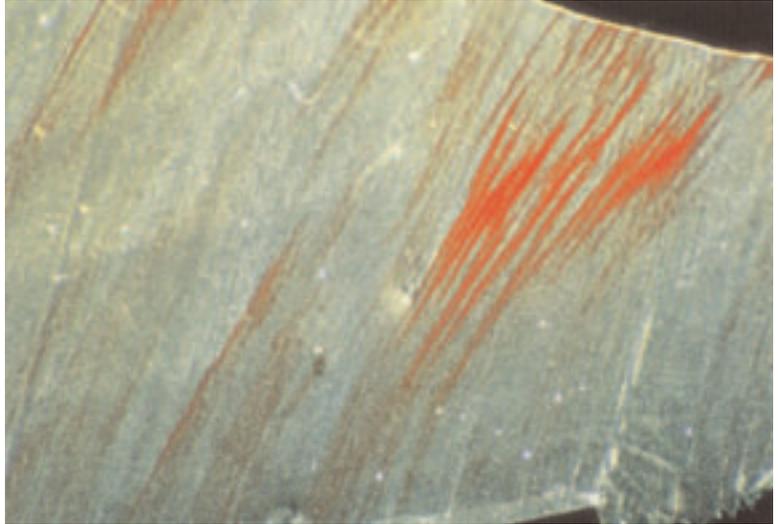
Reason for Failure:
Inhomogeneous melt prevented uniform dispersion of masterbatch.

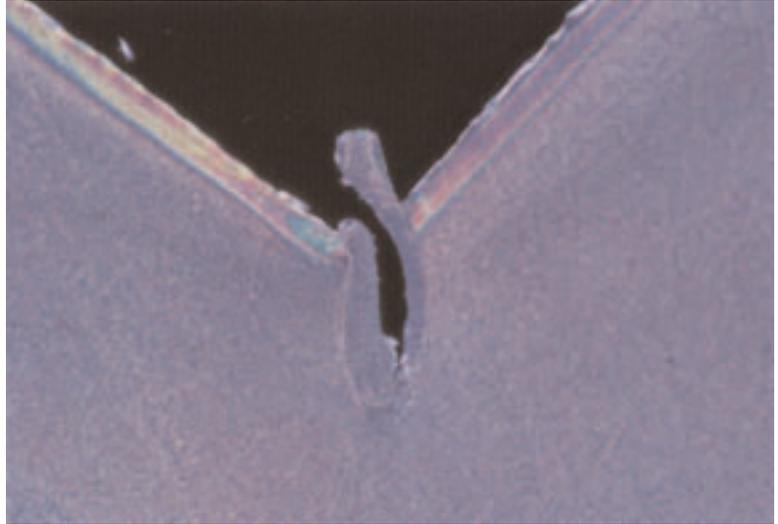
Reason for Failure:
Flash in tooth base due to damaged mould caused notch effect resulting in premature breakage.

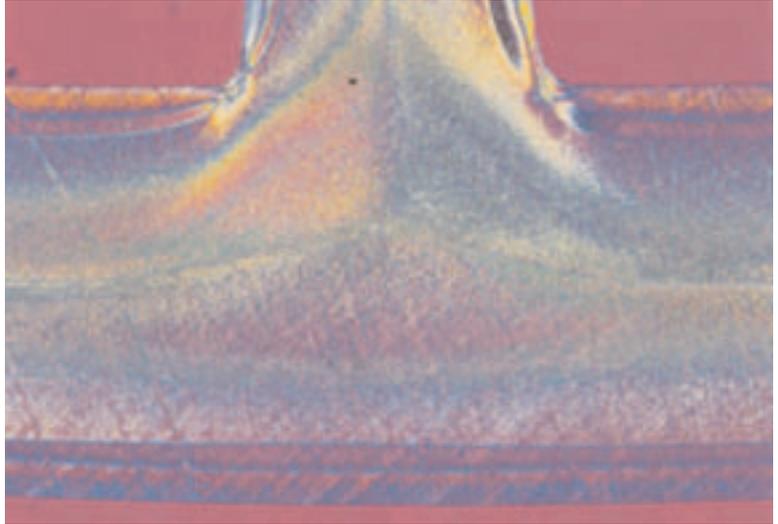
Reason for Failure:
Cracks caused by notch effect from sharp corners in tool. High stress orientation at corners in comparison to non-failing parts.

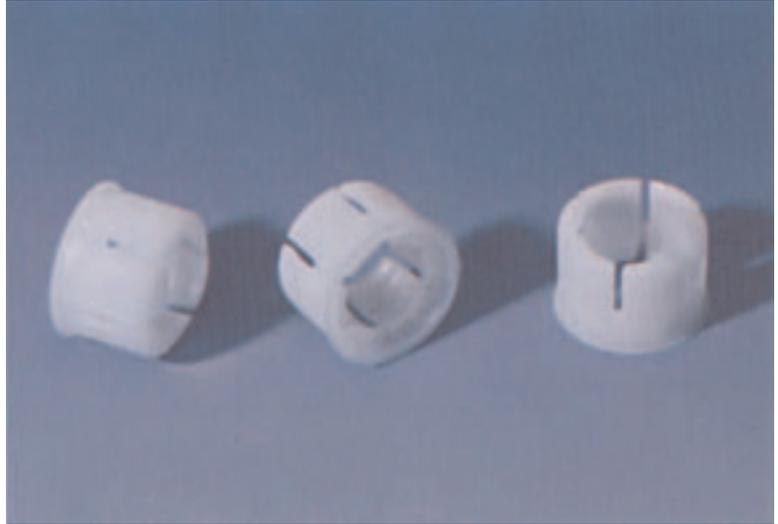
A Part

Reason for Failure:
Flash resulted in notch effect during
assembly.

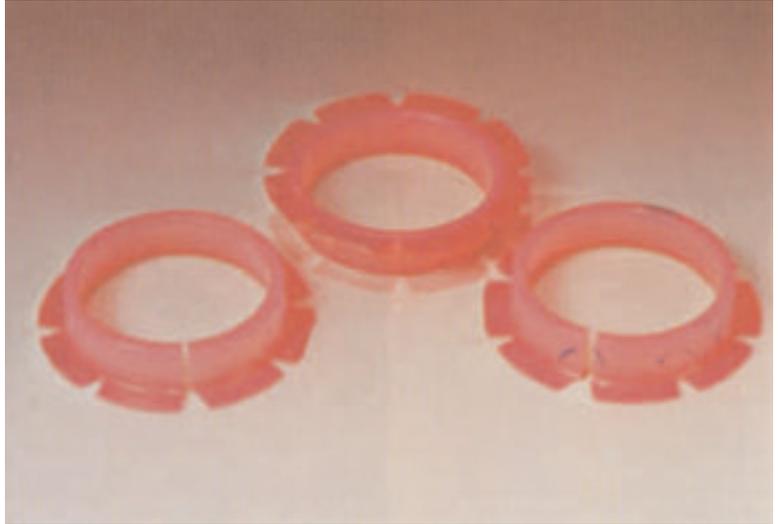
A Part

Remark:
Insufficient clamping force of moulding machine could be the reason for the pronounced flash.

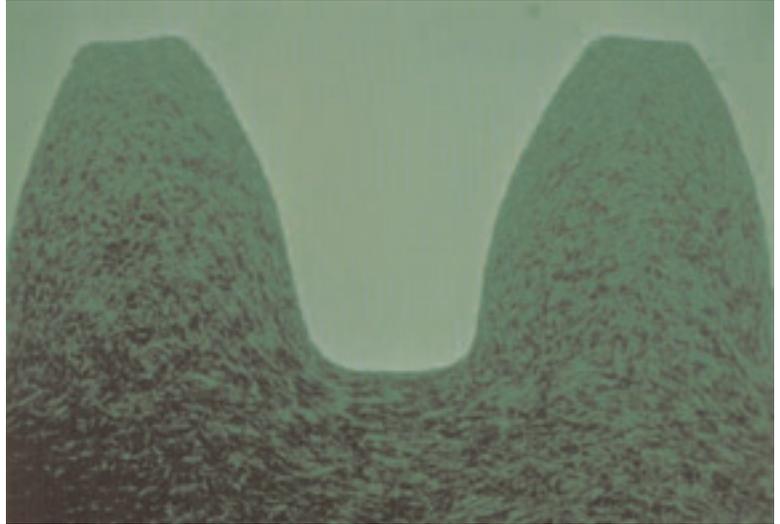
Reason for Failure:
Glass fibres follow the shape of the teeth well. No turbulences or glass fibre agglomeration can be seen.

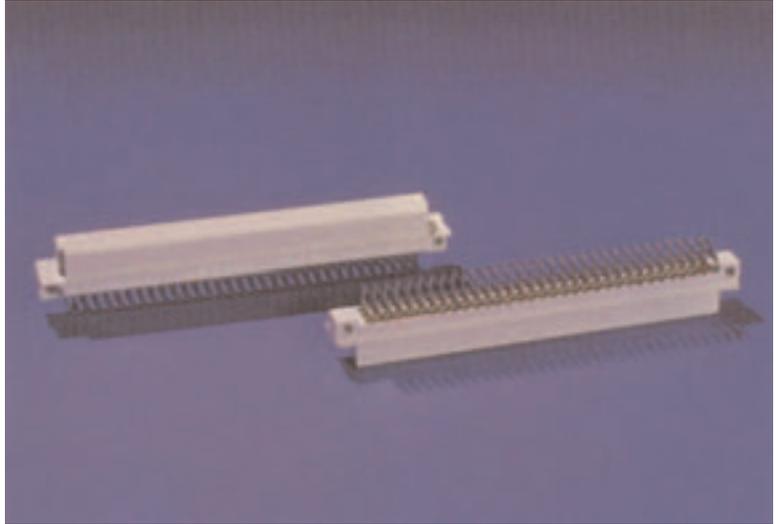
A Parts

Reason for Failure:
By recognizing existing glass fibre orientation, slight changes in moulding conditions reduced differences in dimension of holes within part.

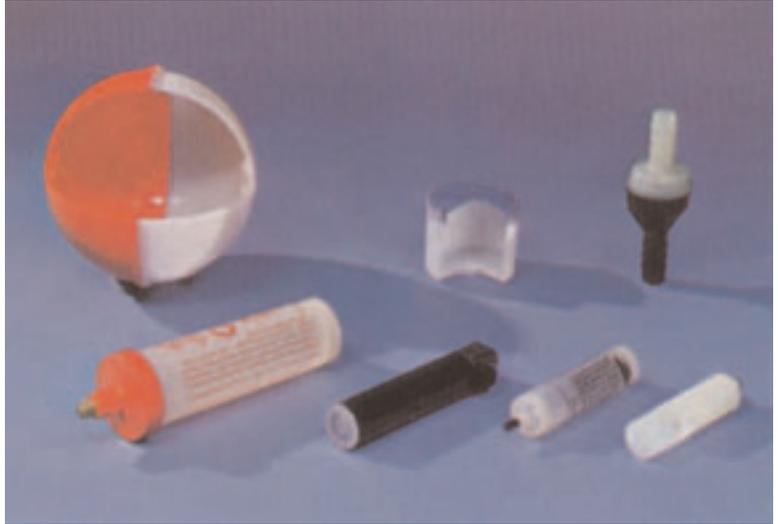
A Parts, spin welded

Reason for Failure:
Area of spin weld not optimally designed. Too sharp angle which cannot be filled and thus did not weld.

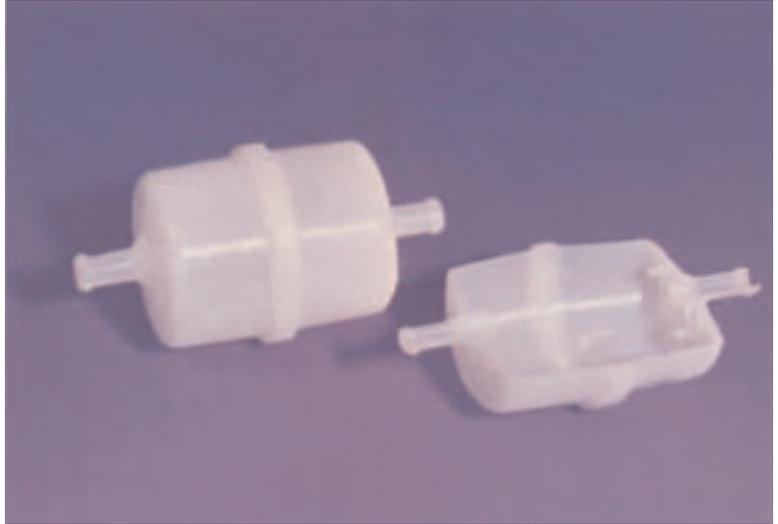
A Part, spin welded

Remark:
Parts which are considered to be of sufficient mechanical strength do not have a perfect weld either. Furthermore, melt temperature of the moulded parts has been too low and inhomogeneous.

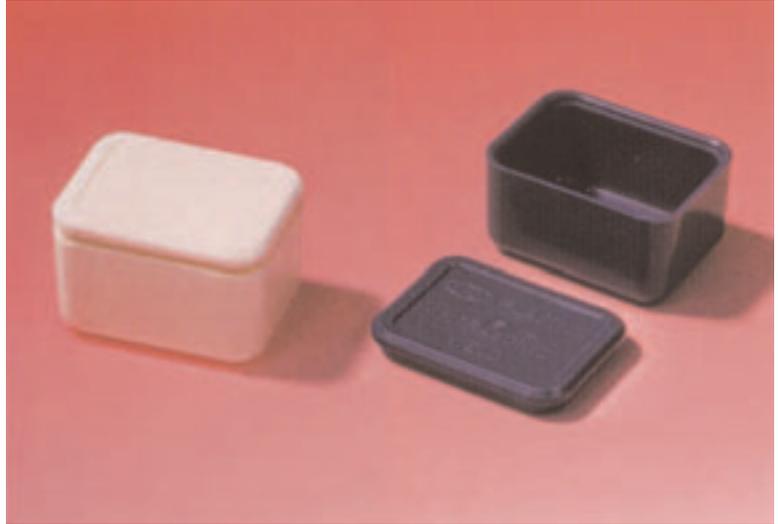
A Part

- POM
- photo B: too long weld time
- photo C: bad dimensional fitting
- photo D: good weld
- photo E: good weld, different part
PA 66
- photo F: material contains too much
moisture
- photo G: good weld, dry material
