DuPont™ Engineering Polymers

Failure Analysis using Microscopic Techniques

Failure Analysis
on Moulded Parts of
DELRIN® and ZYTEL®
using Microscopic Techniques

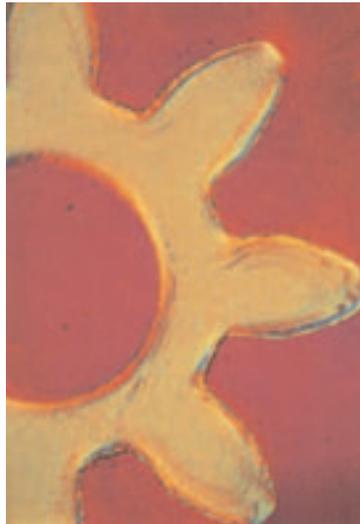
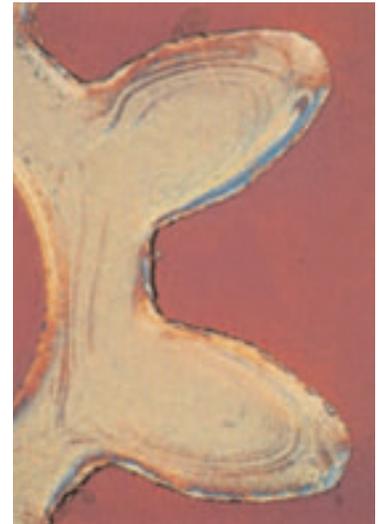
Reason for Failure:
Inhomogeneous melt increased brittleness and lowered resistance to impact load on start-up of gear.

B Inhomogeneous melt

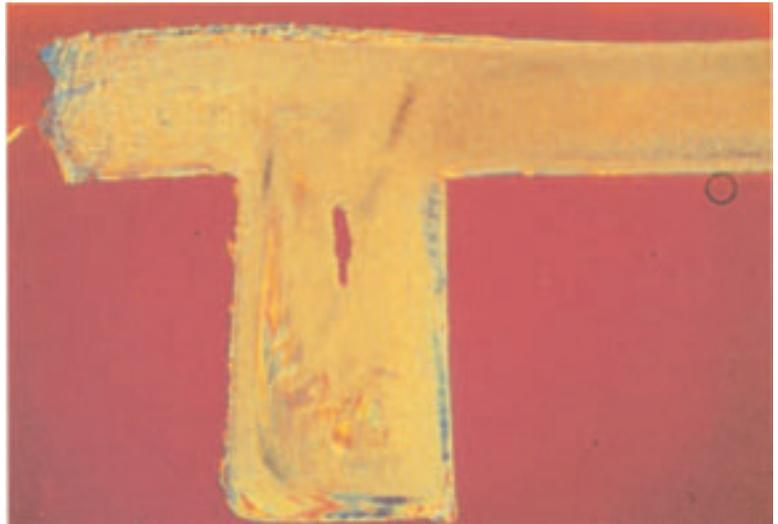
B Void and inhomogeneous melt

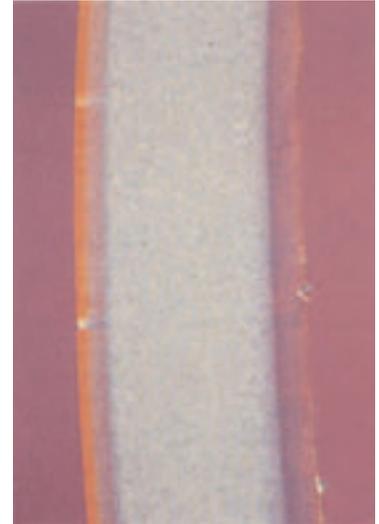
C Homogeneous melt

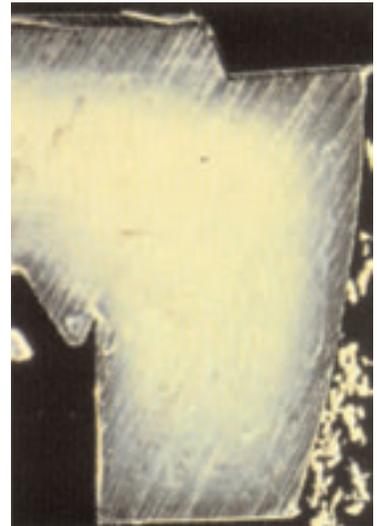
C Head, vertical

Inhomogeneous Melt

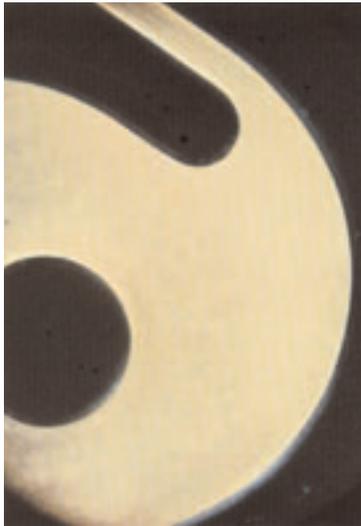
B Gear, natural – good

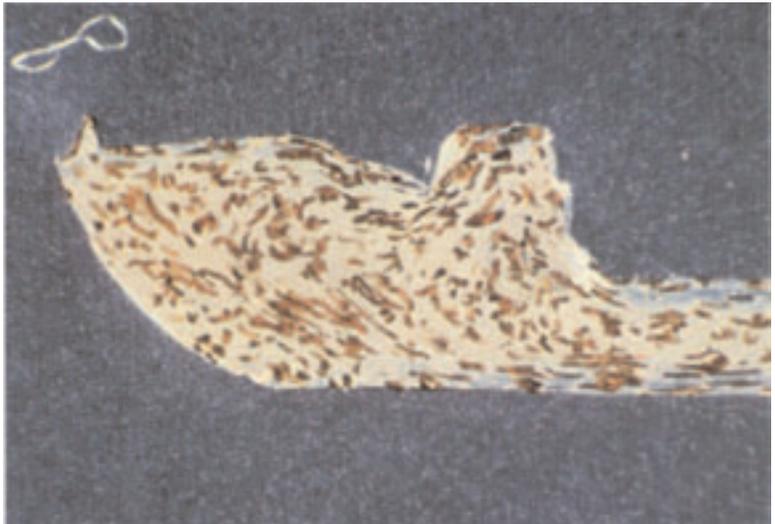
B Homogeneous melt

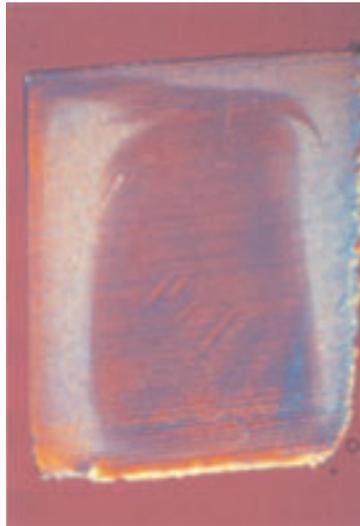
B Inhomogeneous melt

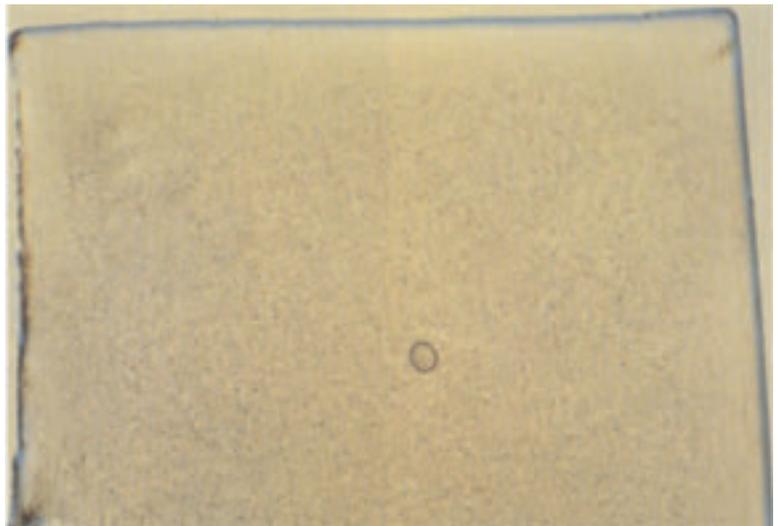
D

Reason for Failure:
Inhomogeneous melt prevented uniform absorption of dye.

Remark:
Speed of water absorption is influenced by size of spherulites. (Smaller spherulites = slower water absorption.) Thus non-uniform size of spherulites caused non-uniform absorption of water containing dissolved dye.

Non-uniform absorption of dye

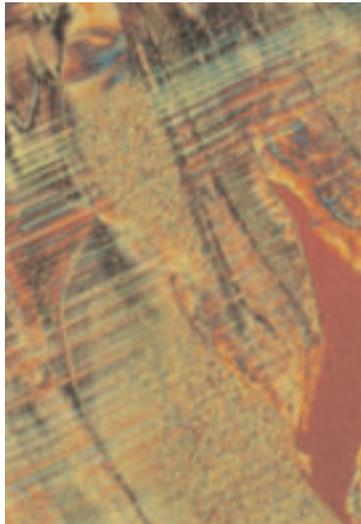
Reason for Failure:
Unmolten particles in extruded material caused brittleness.

B Cross section of A

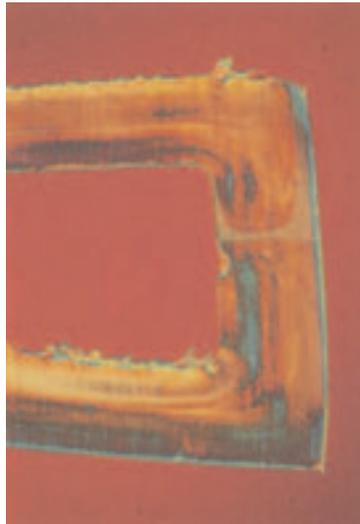
Reason for Failure:
Series of decreasing quality show decrease in homogeneity of structure, e. g. melt temperature was getting lower from one series to the next.

C Strong distortion

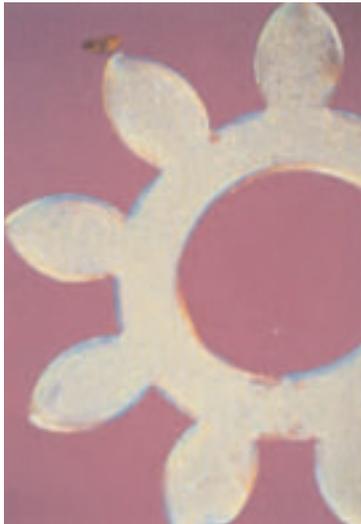
C Weld line between two teeth

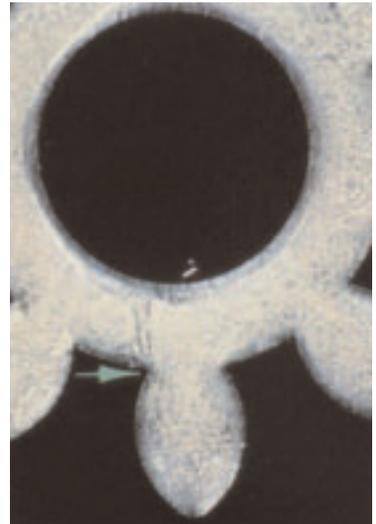
D Weld line at tooth base angle

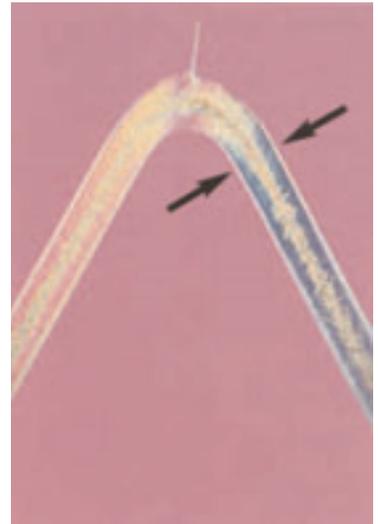
D Cross section at marked area

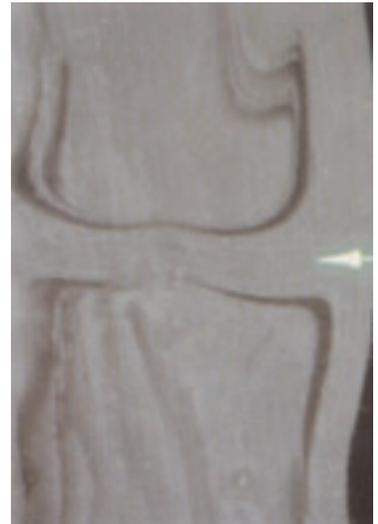
Reason for Failure:
Position of gate in relation to load direction not optimum. In addition, low melt temperature caused weld line.

B Weld line and inhomogeneous melt

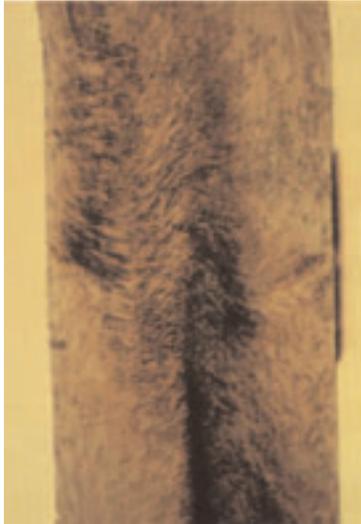
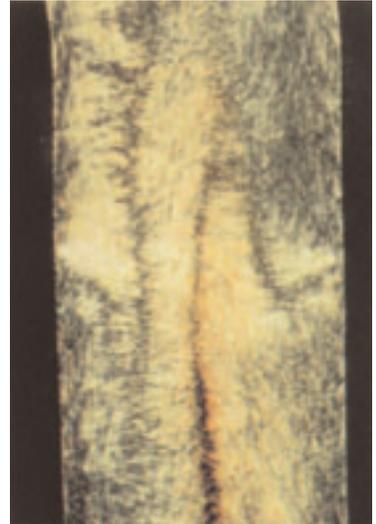
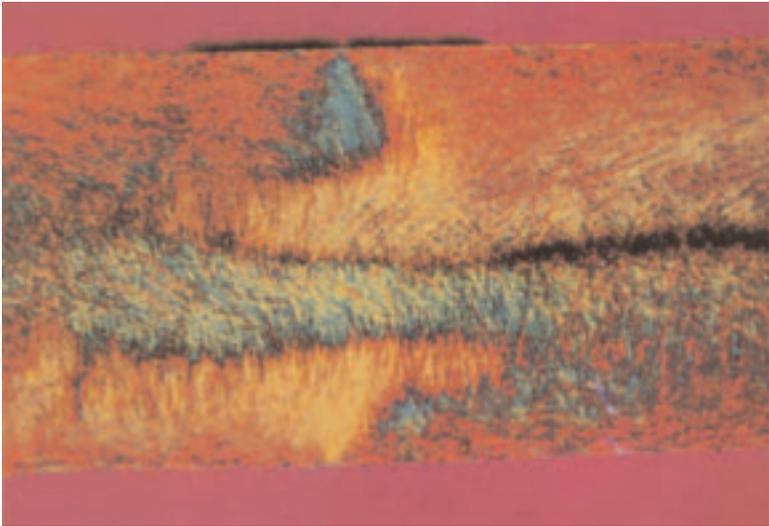
Reason for Failure:
No failure observed. Although weld line is visible in thin polished section, no loss in impact strength compared to other areas of same part.

B Weld line

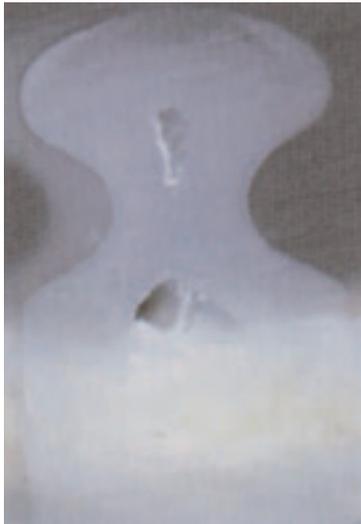
Reason for Failure:
Insufficient filling of mould cavity resulting in voids. Thus, reduced cross section gives lower mechanical strength.

B Cross section

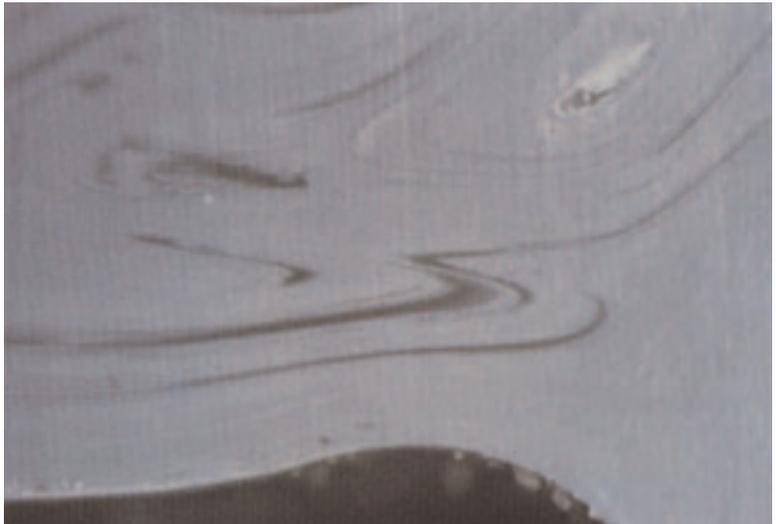
Reason for Failure:
Inhomogeneous melt or too low melt temperature prevented uniform distribution of the colour masterbatch.

B Cross section at area with streaks

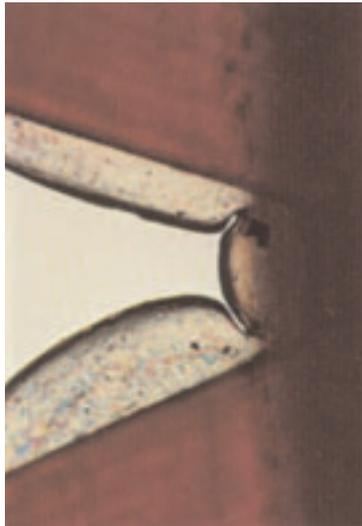
Reason for Failure:
The thin flash cracked under load propagating a notch effect causing the breakage of the ring.

B Flash

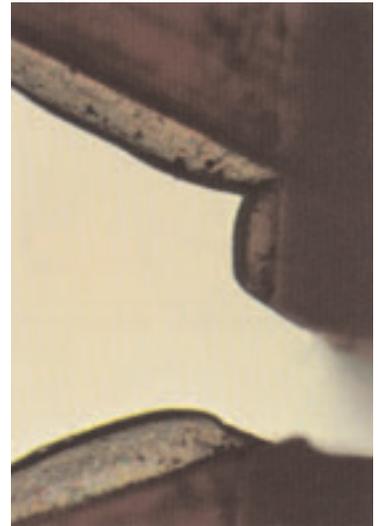
C Broken flash causing notch effect

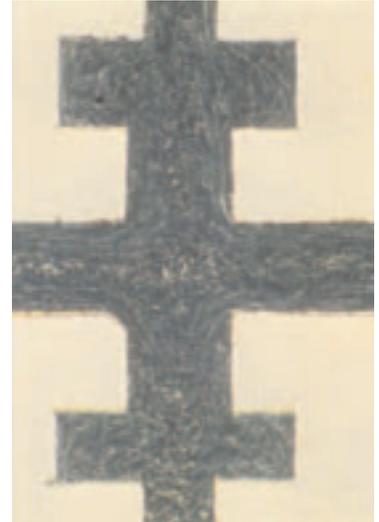
Reason for Failure:
By recognizing existing glass fibre orientation, slight changes in moulding conditions reduced differences in dimension of holes within part.

B Fibre orientation

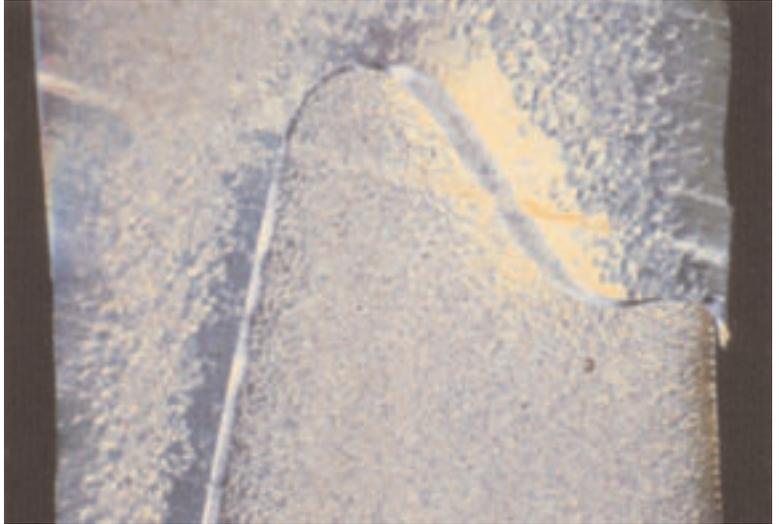
Good weld giving resistance to high burst pressure.

A Good spin weld

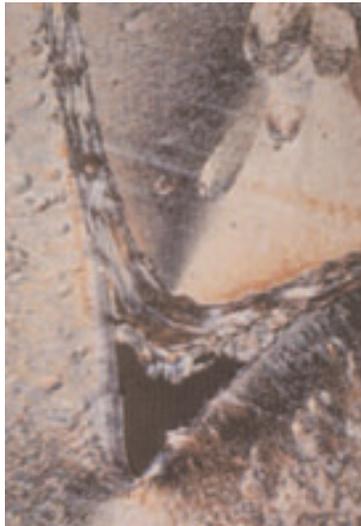
Reason for Failure:
Area of spin weld not optimally designed. Too sharp angle which cannot be filled and thus did not weld.

B Weld area not gas-tight

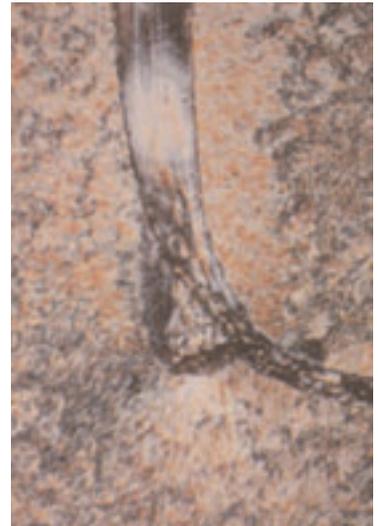
C Good spin weld

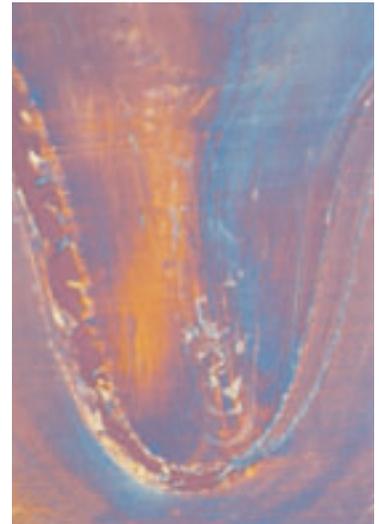
Reason for Failure:
Poor quality of weld preventing good bond between the two halves.

B Not gas-tight but mechanically acceptable

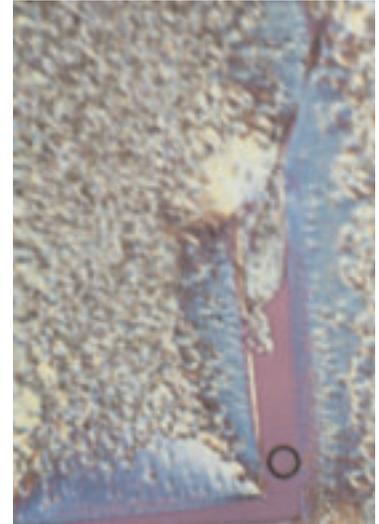
- POM
- photo B: too long weld time
- photo C: bad dimensional fitting
- photo D: good weld
- photo E: good weld, different part
PA 66
- photo F: material contains too much
moisture
- photo G: good weld, dry material

B Weld time too long – POM

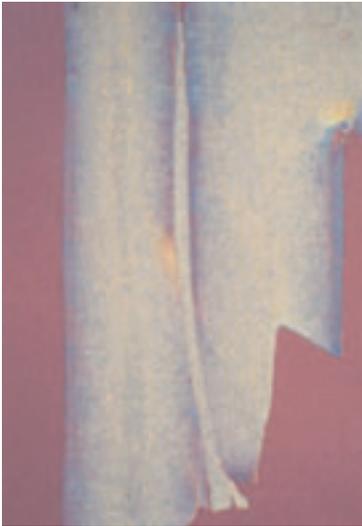
D

Good weld – POM

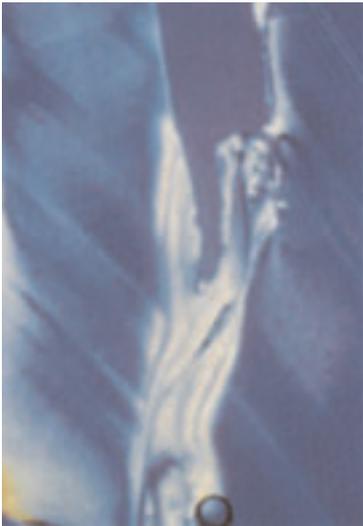
E

Good weld – POM, different part

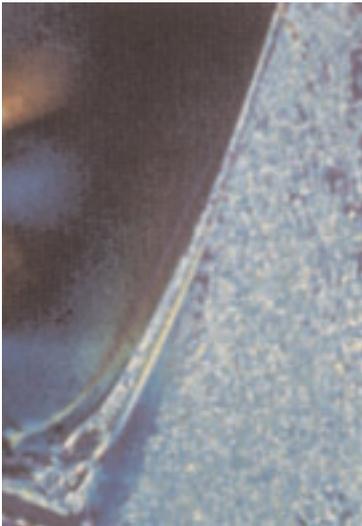
F

Material moist – PA 66
